# Interagency Aviation Accident Prevention Bulletin

No. IA APB 26-09

**Subject:** Misrigged Flight Controls

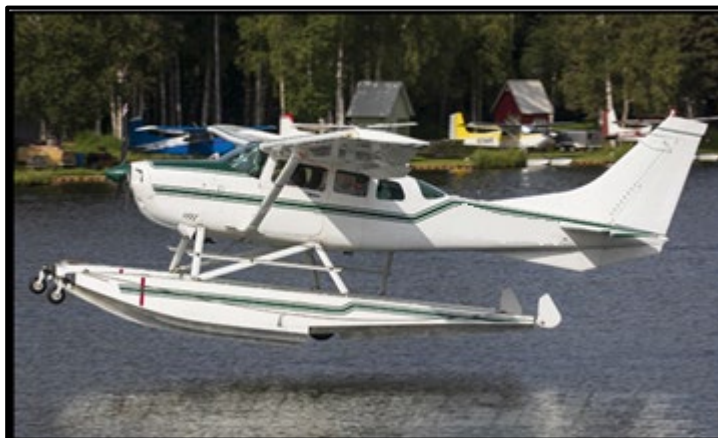
During a post-maintenance check flight in an amphibious float-equipped aircraft, a DOI pilot encountered unusually heavy elevator forces during a waterway takeoff, requiring significant back pressure. After liftoff, the pitch-control difficulty increased, prompting the pilot to divert and land safely on a nearby gravel runway. Inspection revealed the elevator trim system had been installed incorrectly, causing the trim tab to move in the opposite direction and create excessive aerodynamic pressure. This event was reported in a SAFECOM submission [#26-0421](#). In 2023, a USFS pilot experienced a similar event also reported in SAFECOM, [#23-0642](#).

A few days prior to the flight, maintenance personnel completed an annual inspection which was documented in the aircraft logbook (OAS-2 Aircraft Status Log). Multiple discrepancies were corrected. The mechanic replaced the elevator trim actuator, followed maintenance manual procedures, and performed an operational check. However, the manual did not specify the expected direction of trim tab travel, and the mechanic did not notice the incorrect rigging.

- Pilots should receive a detailed briefing on all maintenance performed including access to both the aircraft logbook and maintenance work package to understand which systems were serviced.
- Mechanics must follow all applicable maintenance manual procedures and verify that flight control surfaces move in the correct direction. Maintenance manuals often lack specific guidance on how to conduct operational system checks. If uncertain, seek assistance before returning the aircraft to service. Trim tabs generally move opposite to the primary flight control surface they control.
- Following this event, internal supplemental maintenance procedures were implemented covering flight control trim system maintenance, providing clear guidance for operational checks.
