Interagency Aviation SAFETY ALERT

No. IASA 23-02

Date: August 29, 2023

Subject: Matrice 600 Pro Batteries - Thermal Expansion

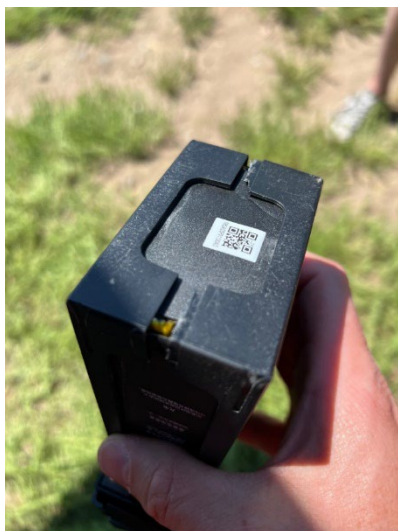
Discussion: Recently, a USGS Uncrewed Aerial System (UAS) crew conducted an aerial photography mission in the Alamosa National Wildlife Refuge using a Matrice 600 UAS with a Yellowscan VX20-100 lidar scanner. The scanner weighs 6.8 pounds. On the last flight of the day, the Remote Pilot (RP) removed the batteries and noticed that one of the six batteries was hot and swollen, causing its plastic case to crack. The battery was allowed to cool, tagged as unusable, and removed from rotation. Refer to [SAFECOM 23-0786](#) for more information.

Figure 2 Cracked M600 Pro battery case.

The Remote Pilot (RP) noted that, while in flight, this set of batteries lost their charge a little faster than the previous sets. They were able to land safely as they monitored the flight for any further degradation.

Batteries swell when the electrolyte in the battery decomposes. In the case of LiPo batteries, the nature of the electrolyte tends to produce gasses such as carbon dioxide (CO₂) and carbon monoxide (CO) when they decompose. The layers of the battery are sealed in an airtight case. The production of these gases is what causes the LiPo battery to expand and swell.

A swollen battery is a sign that the battery is losing its ability to maintain a sufficient charge. LiPo batteries are constructed with thin layers that are coated with a chemical that contains lithium which becomes highly volatile when exposed to oxygen. Use caution with LiPo batteries that are compromised as they can pose a fire hazard!

Heat is the number one cause of a swollen battery. Other factors like totally depleting their charge, flying in high winds, or aggressive flying on a hot day can cause the internal temperature to spike.

DJI recommends the following maintenance procedures for the batteries:

- Store the batteries in a waterproof and moisture-proof area. If the battery is idle for more than 10 days, discharge the battery to 40% to 60% of the total battery level. Recharge and discharge the battery once every 3 months to maintain battery health.
- As the Matrice M600 Pro batteries get older, aircrews should continue to monitor them carefully and try to keep them out of the sun.
