# Interagency Aviation Tech Bulletin

No. IA TB 24-01

**Subject:** Plastic Aerial Ignition Spheres with Energetic Reactions

**Area of Concern:** Plastic Sphere Dispenser Operations

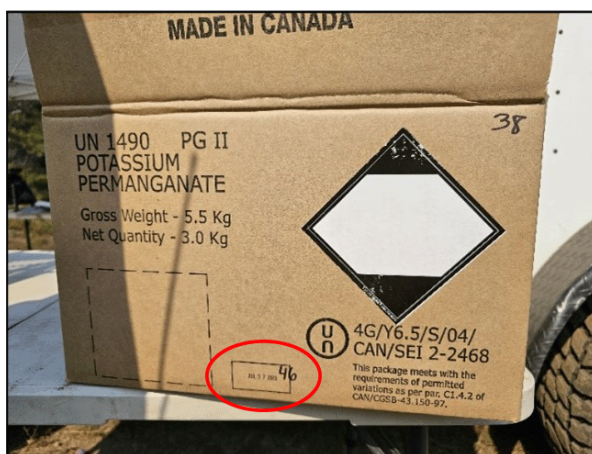
Dragon Eggs contain an additive mixed with potassium permanganate to slow the reaction time after the spheres are injected with glycol. However, it has been confirmed no slowing additive was applied to the batches that are experiencing quick reactions. One pallet of 50 affected boxes was shipped to Type One Incident Support, a U.S. distributor located in Oregon. Each of the boxes of Dragon Egg spheres has a manufacture date stamped on the lower side (figure 1) to easily identify the known affected spheres.

Figure 1 – The Dragon Egg plastic ignition sphere box includes a date of manufacture on the lower center of the box (circled in red).

**Recommendation:** Boxes stamped July 14-17, 2023, must be removed from service.

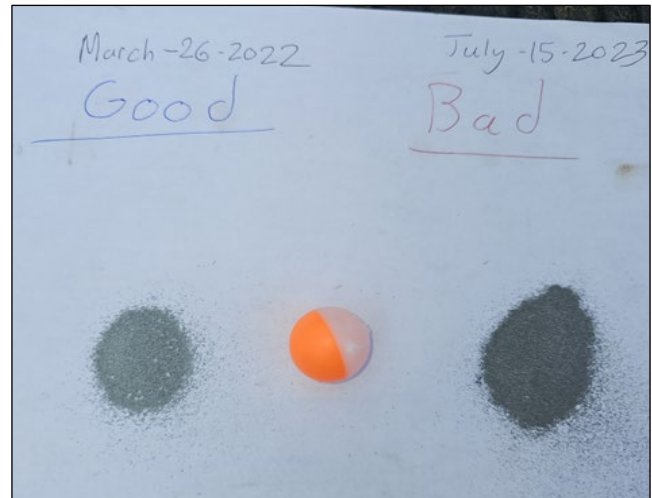
Figure 2 – The photo displays potassium permanganate. On the left side, it is depicted in its normal, lighter shade. On the right side, the potassium permanganate appears darker, indicating it has been affected.

1. Note the date on the box and stop use.
2. Contact the company or the agency aerial ignition representative (listed below).
  - a. Upon reporting you may be asked to break a sphere open to reveal the contents and report the color of potassium permanganate. Affected spheres will have a darker colored potassium permanganate than spheres containing the additive that calms the reaction (figure2).
3. Replace affected product. Replacement of the spheres can be completed by contacting Type One Incident Support or SEI Industries.
