Interagency Aviation Safety Alert

No. IA 08-03

Subject: Esmet 3000 Pound Swivel
Area of Concern: All Helicopter Operations
Distribution: All Fire and Aviation Personnel

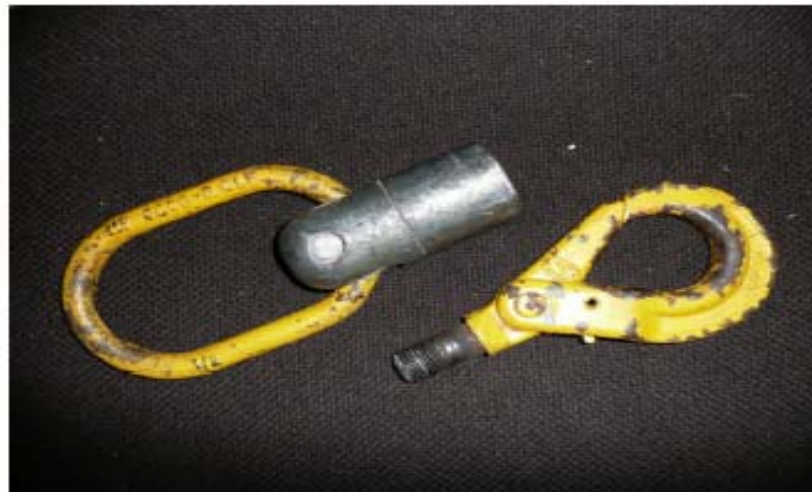
Discussion: SAFECOM 07-0956: “While transporting a cargo net with 9 pieces of roofing material, a box of roofing screws and a box of roofing gaskets to a remote cabin, the hook of the swivel separated from its body resulting in the load falling approximately 150-200 feet. The load weighed 332 pounds including the weight of the net and swivel...Maintenance staff retrieved the hook part of the swivel from the dropped load...” The swivel had a manufacturing date of “3-04” and had been used extensively since its purchase without any problem. Below is a photo of the swivel that failed.

Prior to use, the swivel was inspected in accordance with National Fire Equipment System Cache Memorandum No. 05-02. No discrepancies were found and the swivel turned freely. According to an Esmet Design Engineer, corrections for the issues involved with the swivels identified in the Cache Memo 05-02 were supposed to be corrected with the installation of a locking nut in those units manufactured after March 2004. During a follow up investigation, the manufacturer recommended that any swivel with a gap of 1/8 inch between the hook and the housing be taken out of service.

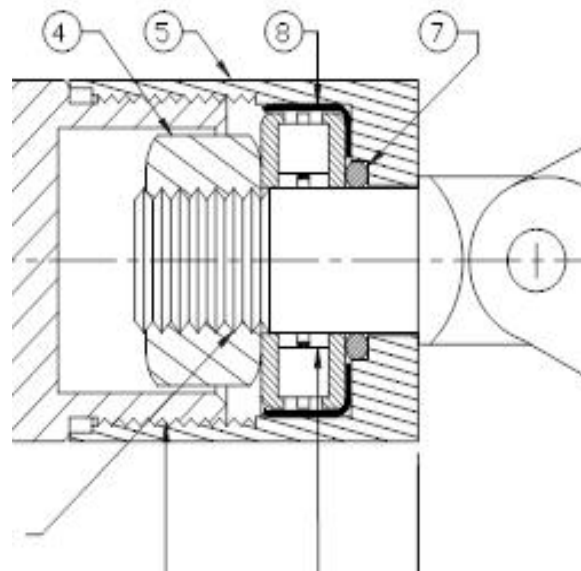
In the design view below, (4=locking nut, 5= swivel body tube, 7=o-ring, 8= bearing), little clearance is shown for the hook shaft indicating that any asymmetric (uneven) lateral movement would be abnormal indicating deformation of the bearing or housing.

Corrosion may be reduced by storing the swivel so that the hook hangs beneath the swivel and using WD-40 to displace any water that may have accumulated in the shaft area. The Design Engineer at Esmet has confirmed that this will not affect the o-ring installed at the base of the bearings within the housing body. The bearings on these swivel units are sealed so lubrication of the bearings is not possible.

Although Cache Memorandum 05-02 allows lateral movement and some restricted turning of the hook, it is recommended that any swivel with either asymmetric (uneven) lateral movement or that has any type of restriction to rotation be taken out of service. According to the Esmet Design Engineer, side loading can cause internal damage and may be the cause of this hook failure as well as the corrosion at the base of the threads. A visual inspection should be performed prior to and after each use, looking for any gap distance from the hook to the body or the hook no longer being in line with the overall assembly. Operations in high humidity or salt water environment will increase corrosion in the swivel assembly.
