Interagency Aviation TECH BULLETIN

No. IATB 2014-03

SUBJECT: Onboard Systems Bell 206L/407 Manual Release Cable

Subject: Bell 206L/407 Manual Release Cable

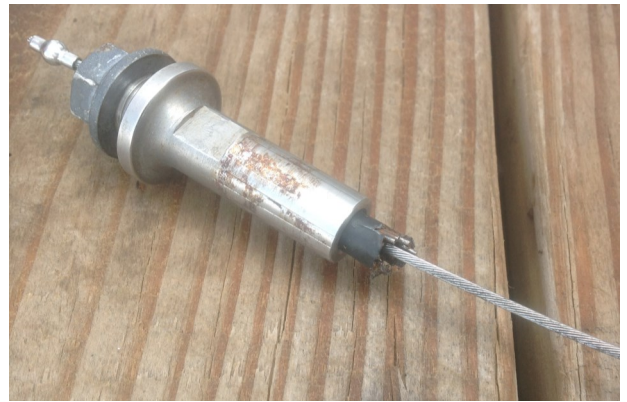
Recently, the pilot of a Bell 407 was providing bucket drops with a 100' longline when he discovered his bucket and longline was missing (SAFECOM 14-709). The pilot thought he may have inadvertently hit the emergency release button after the last drop. The pilot, chief mechanic, HMGB, and HEB2 inspected the hook to determine the cause. The electrical check and all standard hook checks were normal. The mechanic cleared the helicopter for normal use, with all personnel agreeing the pilot accidentally triggered the emergency release button. A decision to use the 2nd bucket was made and during the next cycle, the pilot proceeded to drop 2 buckets of water and was returning to the dip when he felt the 2nd bucket release from the cargo hook. Throughout this cycle he was very cognizant of his hand placement on the cyclic. Upon returning to base the pilot, chief mechanic, HMGB, and HEB2 again inspected the hook. After multiple successful electrical and standard hook checks, the mechanic uncovered the sheath that protects the emergency manual release cable. The mechanic was then able to determine damage to the release cable thus the potential cause of an un-commanded release. He verified the cable would release the bucket by manually pulling the cargo hook back to a 45° angle to the rear of the helicopter (similar to what would be experienced during flight with an empty bucket, just coming off a drop).

- 1) **Replace** Manual Release Cable P/N 268-004-00 or 268-011-00 with Manual Release Cable P/N 268-004-01. The redesigned Manual Release Cable incorporates more flexible conduit, improved end fittings, and increased length. These improvements extend the service life of the manual release cable.
- 2) Conduct daily pre-flight checks of the manual release cable and replace it as condition requires. A warning placard, P/N 215-272-00, is affixed to the current version of the 268-004-01 cable. The placard expresses the messages (pg 2 of the attached Service Bulletin) and draws attention to the cable condition. ***Careful cable inspection and timely replacement is essential to continued safe operation.***

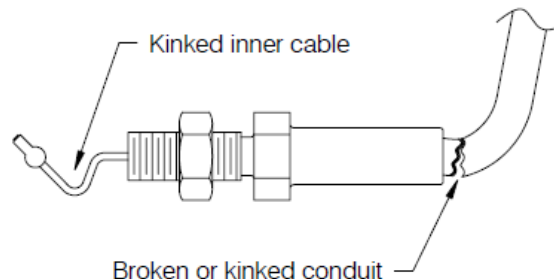
Mechanical release cables are wearable items & must be replaced as condition requires.

As shown below, broken or kinked conduit, inner cable kinks, frays, or sticky operation are each cause for immediate replacement.

Check condition prior to each external load mission & replace as condition requires

- Route to avoid strain
- Rig with proper free play
- Replace as condition requires

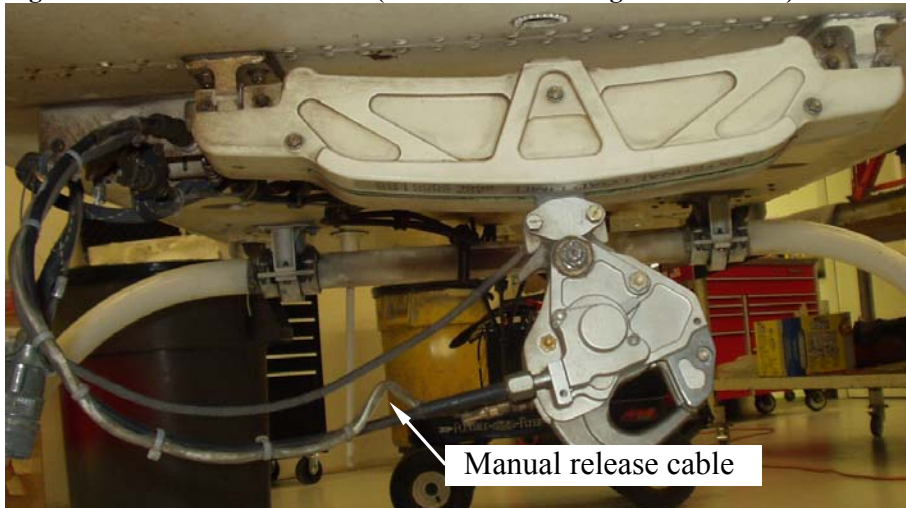
Figure 1 Manual Release Cable (200-259-00 kit configuration shown)

Description: Onboard Systems has had reported cases of failure of the Manual Release Cable P/N 268-004-00. This cable is used to connect the release mechanism of the cargo hook to the fixed manual release cable as part of the backup release system (see Figure 1). Failure of the mechanical release cable can cause an uncommanded release.

1) *Replace* Manual Release Cable P/N 268-004-00 *or* 268-011-00 with Manual Release Cable P/N 268-004-01. The redesigned Manual Release Cable incorporates more flexible conduit, improved end fittings, and increased length. These improvements extend the service life of the manual release cable.

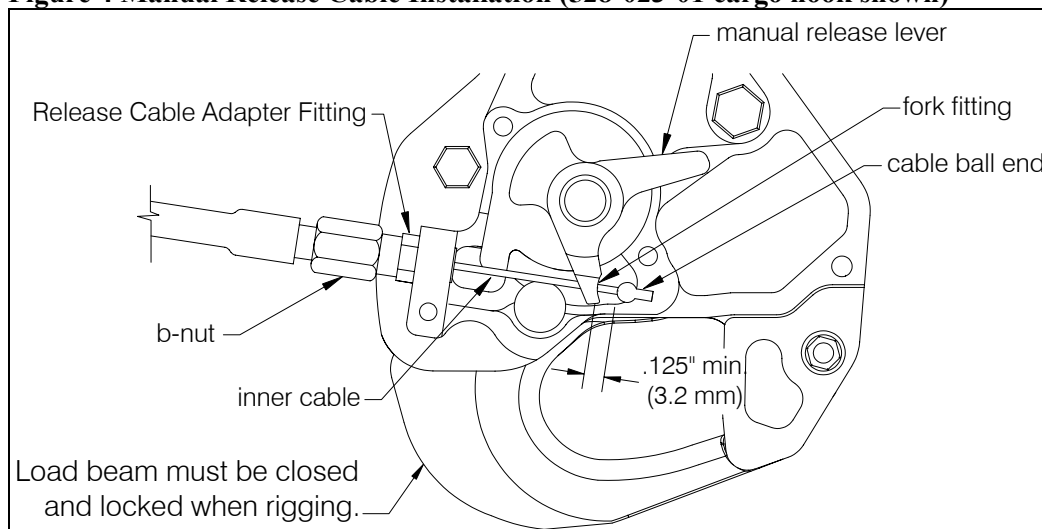
Figure 4 Manual Release Cable Installation (528-023-01 cargo hook shown)

several degrees before free play is taken up) and measure the gap between the cable ball end and the fork fitting as shown in Figure 4. This gap should be a minimum of .125 inches (3.2 mm).

Failure to appropriately rig the manual release cable free play will result in uncommanded release of load.

- At the cargo hook insert the inner cable through the release cable adapter fitting and the fork fitting (see Figure 4)
- Thread the manual release cable's b-nut onto the release cable adapter fitting and tighten securely.
- Verify the Manual Release Cable is rigged correctly by rotating the manual release lever in the clockwise direction to remove free play (this is felt as the lever rotates relatively easily for

Adjustment of the manual release cable free play must be accomplished with the cargo hook in the closed and locked position.
