ACCIDENT PREVENTION BULLETIN

No. DOIAPB 17-01

Subject: Honeywell/Lycoming T-53 Series Engine Compressor Stator Vane Retaining Bolt

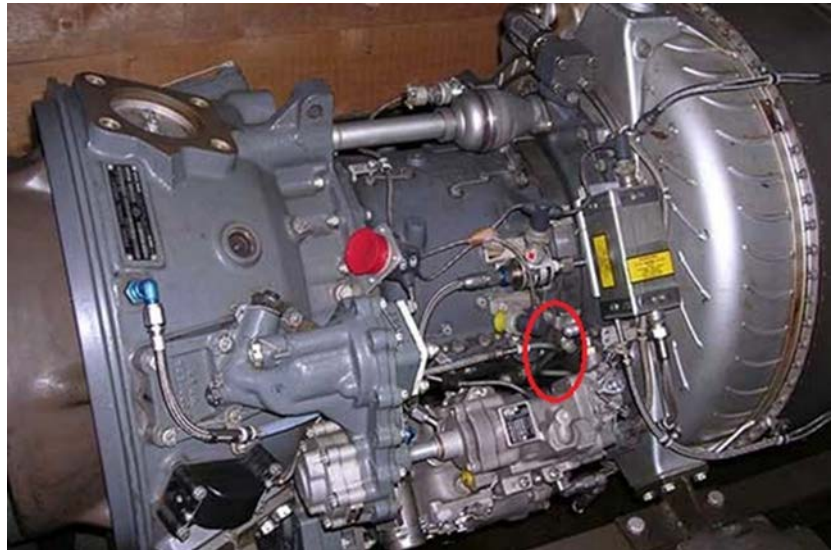
Discussion: During a recent inspection, an OAS Aviation Safety Compliance Specialist discovered the 5th stage compressor stator vane retaining bolt had backed out of its recessed mount hole. The only thing preventing the bolt from falling out was the engine bleed band. Upon further inspection, it was determined that the lock cup had been properly staked to the stator retaining bolt but had not been staked to the compressor housing (as required) which allowed the bolt to loosen. An inspection of the operator's second aircraft revealed the same discrepancy.

concerns that this condition could be present in other aircraft with this particular engine type. Ultimately, this could allow the stator vane assembly to move and contact the rotating compressor. Compressor stalls could result from the bolt binding in the mount hole and preventing bleed band closure.

Operators with this type of engine should inspect this area in order to prevent a possible engine malfunction.

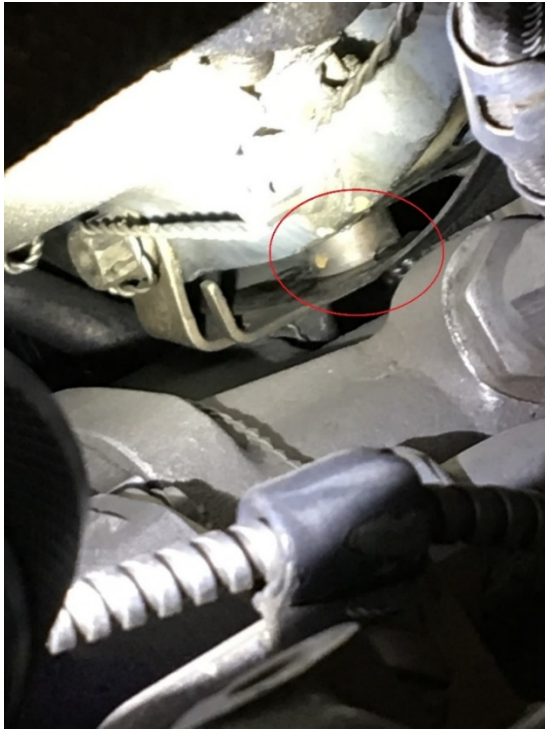
Stator vane retainer bolt lock cup visible at the 8 o'clock position between the compressor case and the bleed band.

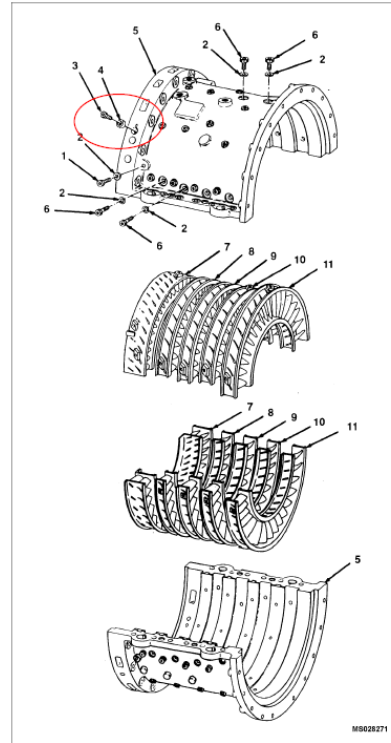
Retainer bolt and lock cup pictures in the 2 o'clock position. Hardware is also installed in the 4, 8, and 10 o'clock positions.
