Interagency Aviation TECH BULLETIN

No. IATB 18-03

Date: August 27, 2018

SUBJECT: Aerospace Filtration System (AFS) Engine Air Filter System – Possible Seal Failure

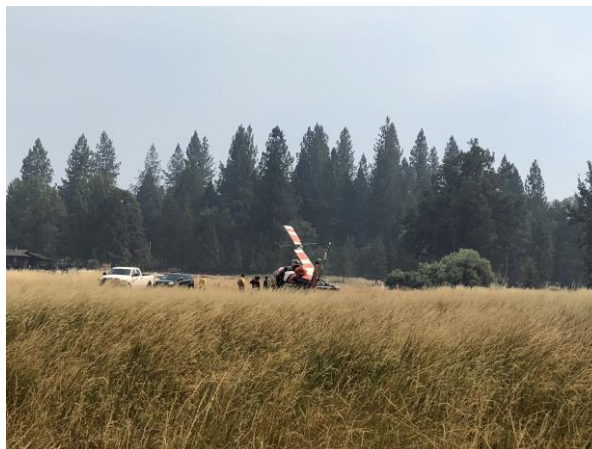
As a result of the incident described, the helicopter company completed a proactive inspection and discovered cracks in both upper and lower seals on the engine to transmission drive shaft cover. This was documented in SAFECOM ([18-0699](#)).

The USFS and DOI directed all contract Bell Medium Helicopters operators with Donaldson AFS filters installed to perform a onetime inspection of all filter seals. A letter was distributed to all affected vendors through the contracting officer as a means of immediate notification. The Technical Bulletin documents the inspection process required in accordance with AFS-BH205-IBF-ICA. If seals require replacement, parts and sealant called out in the AFS document must be used (see diagrams shown on pages 2 and 3). Contracted operators were required to complete this onetime inspection within 8 flight hours or one day (24 hours) of receipt of Contracting Officer notification. No operators reported discrepancies with the AFS field installation.
