element environmental llc
environmental · engineering · water resources

June 26, 2024

Subject: **Preliminary Site Investigation Letter Report**
Varona Village Parcels
Ewa, Oahu, Hawaii
Tax Map Key (1) 9-1-182: Parcels 007 and 010

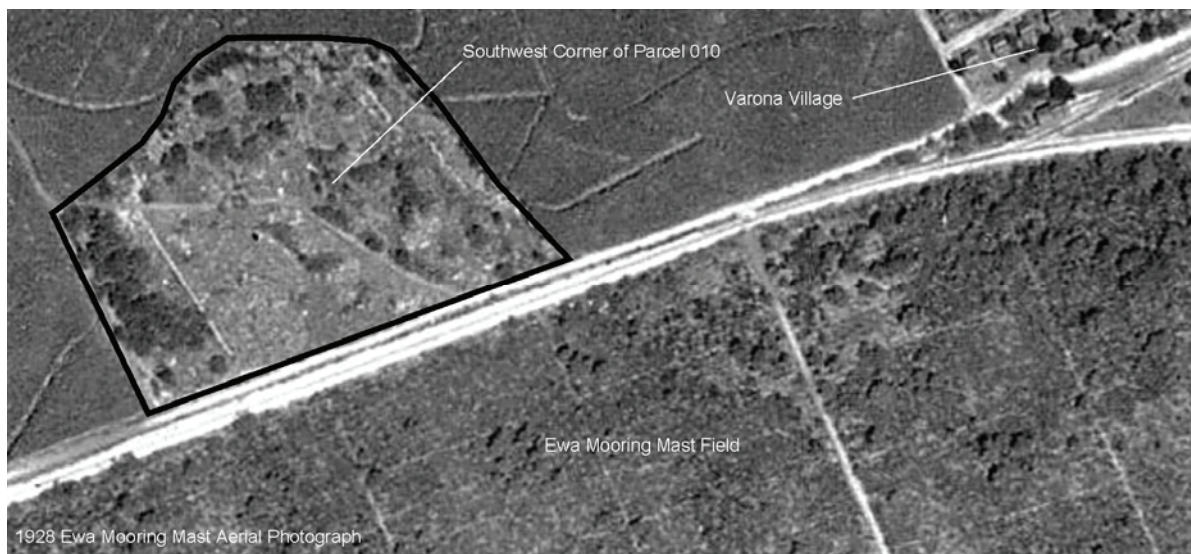
- 1902 Hawaii Territory Survey Map²: A portion of the subject property adjacent to the north side was used for sisal crops; the remainder to the north was part of the Ewa Plantation Co. sugar lands.
- 1922 United States Geological Survey (USGS) Fire Control Map³: Shows the Varona Village plantation housing development.
- 1928 Aerial Photo⁴: Shows an unidentified development/use of the southwest corner of Parcel 010 (approximately six acres) surrounded by cane fields (see photograph on the following page). This development was adjacent to the OR&L right-of-way. The Ewa Mooring Mast Field was located across the railroad tracks to the south.

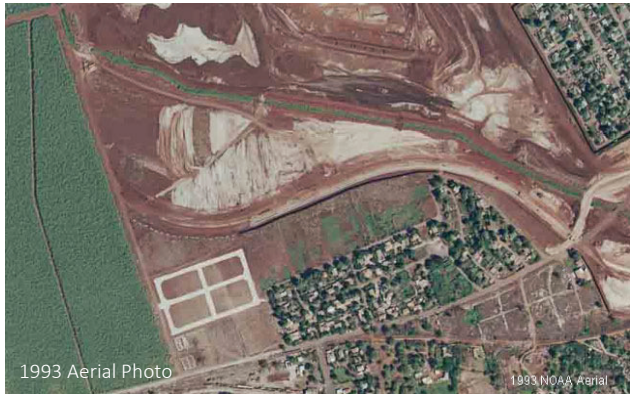
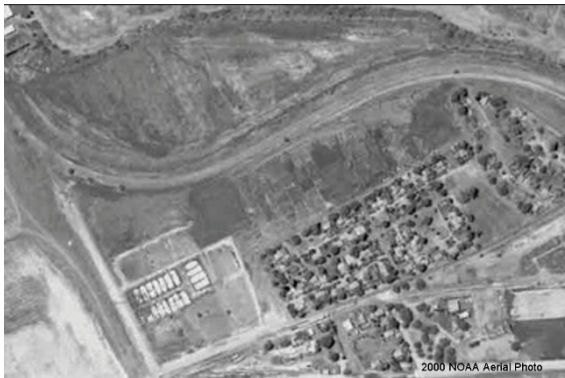
- 1993 National Oceanic and Atmospheric Administration (NOAA) Aerial Photo¹⁰: Shows the Kapolei Parkway construction is underway. The west side of Parcel 010 has been graded and was likely used as a construction base yard.

- 2000 NOAA Aerial Photo¹¹: Shows both the Kapolei Parkway and Ka Makana Alii construction. The west side of Parcel 010 was likely used as a construction base yard.

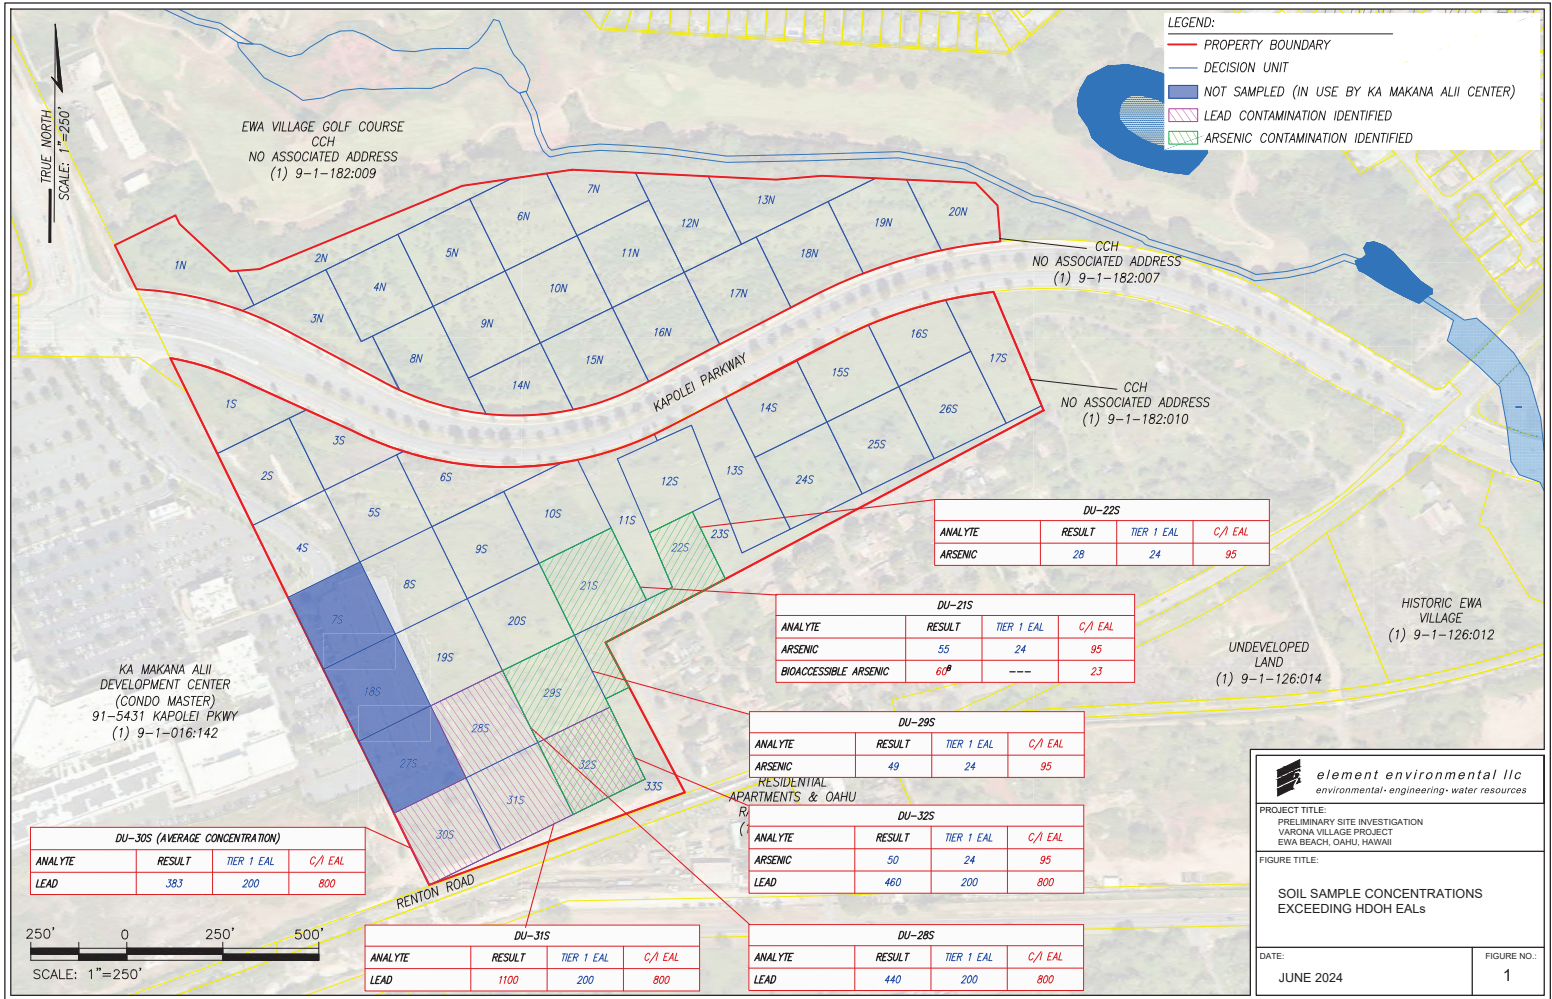
Figure 1 – Soil Sample Concentrations Exceeding HDOH EALs
Table A – Soil Sample Analytical Summary Data Table
Laboratory Reports
Photo Plates

The property was divided into 53 decision units (DUs), each approximately 1-acre in size. The DUs were labeled as DUs-1N to -20N and were located on the northern parcel, Parcel 007, while DUs-1S to -33S were located on the southern parcel, Parcel 010. The DU layout is presented in Figure 1, attached. Three of the 33 DUs within Parcel 010 (DUs-7S, -18S, and -27S) are occupied by paved parking as part of the Ka Makana Alii development and were not sampled (refer to the DUs highlighted in blue in Figure 1).

None of the contaminants of potential concern (COPCs) were detected in Parcel 007 surface soils at concentrations exceeding HDOH EALs. Only two COPCs, arsenic and lead, were identified Parcel 010 soils at concentrations exceeding HDOH EALs. Bioaccessible arsenic was identified in the soil at concentrations within ASCM Category C. All of the above detections were in DUs located within the southwest portion of Parcel 010 (see Figure 1 attached).

- Lead and/or arsenic were detected in seven DUs located in the southwest corner of the parcel and adjacent to the north side of Varona Village at concentrations exceeding HDOH Tier 1 EALs for unrestricted (residential) land use.
- Lead was detected in one DU (DU-31S) located in the southwest corner of the site at a concentration of 1,100 mg/kg, exceeding the HDOH C/I EAL. The lead may be associated with a potential dumping ground that was observed in this DU. Lead concentrations in excess of 800 mg/kg pose a direct exposure risk to construction and trench workers.
- Bioaccessible arsenic was detected in one DU at a concentration placing the soil in ASCM Category C, which limits the use of this DU to commercial/industrial use.

The HDOH Hazardous Evaluation and Emergency Response (HEER) Office typically requires complete characterization of soil at construction sites where the potential presence of contamination is suspected prior to development.
