# Interagency Aviation Lessons Learned

No. IA LL 21-01

**Subject: Fire Boss Scooping Operations**

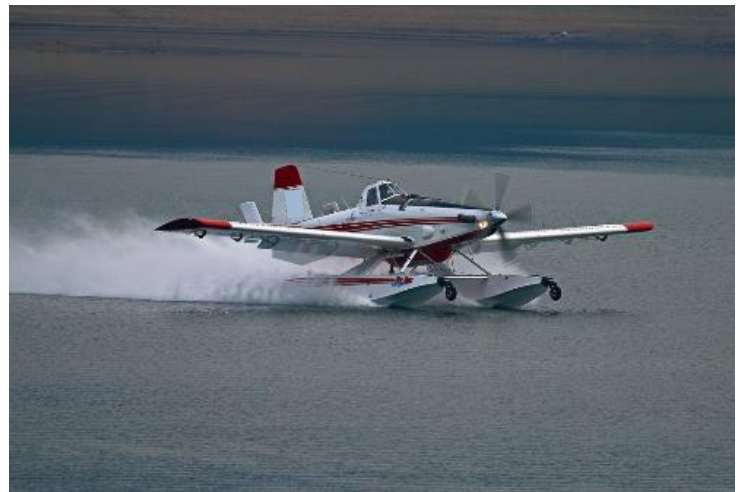
wide, about 4 miles north of the fire. The pilots determined that the lake was free of obstructions in the water and on the approach end of the lake. There was however, a small hill roughly 20 feet in height located at the departure (east) end. While departing with load number 12, the mishap aircraft impacted the hill with the left float. The pilot was able to continue the departure and climb to altitude where he could assess the aircraft's condition. When the pilot began to smell fuel in the cockpit, he elected to divert and land at an airport located approximately 14 miles west of the fire.
