Interagency Aviation ACCIDENT PREVENTION BULLETIN

No. IA APB 11-01

Subject: Aerial Ignition Operations

Area of Concern: Plastic Sphere Dispensing Units (PSDs)

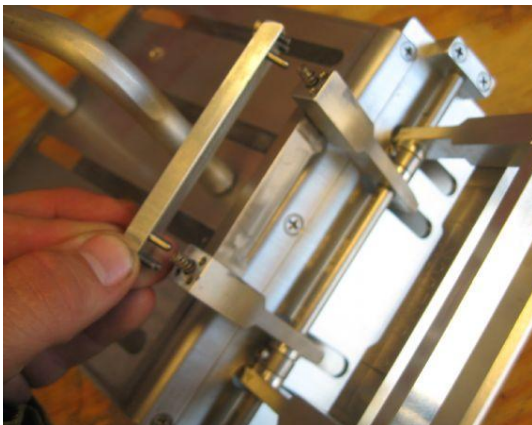
Figure 1. PSD Lever

During a routine cleaning of a PSD machine between aerial ignition operations, the lever controlling the inside chutes was discovered to be more difficult to operate (Figure 1). Upon closer inspection, one of the pins required for holding the springs in place was found to be worn beyond limits (Figure 2) and the asymmetrical shape prevented the lever from traveling smoothly. Had this discrepancy not been discovered, the PSD could have jammed in flight resulting in a cancelled mission and needless waste of resources.

It's important to inspect each box prior to use/loading for broken spheres or loose permanganate. If broken or deformed spheres are found, do not use them and secure them in a safe location. Afterwards, contact your Regional /State Helicopter Operations Specialist or agency aerial ignition representative. Maintaining the cleanliness and preventative maintenance of the PSD machine per the instructions in the Inter-agency Aerial Ignition Guide should mitigate most of these hazards associated with PSD operations.

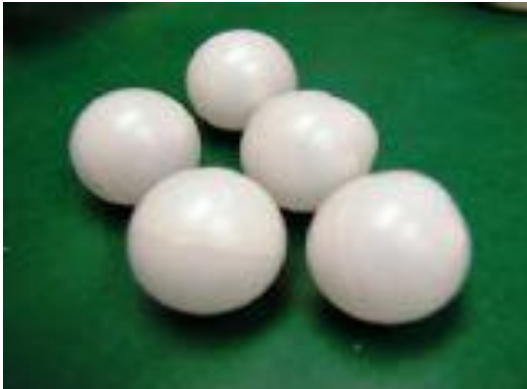
Figure 3. Deformed spheres

In a separate incident, the PSD operator noticed the two outside hopper chutes were not moving thus restricting the spheres from reaching the glycol/needles. The operator secured the machine while the helicopter returned to the helispot. After landing, the machine was removed and examined where it was discovered that the two outside chutes of the hopper were jammed with a blown fuse.

While removing the remaining spheres from the jammed hopper to change the fuse, the crew noticed some of the spheres were warped or possessed a raised blister-like bubble deformation (Figure 3). The deformed spheres caused the chute to jam, resulting in the blown fuse. The dimensions of the sphere should be 32 mm (1.25 in.) in diameter and contain approximately 3.0 grams of potassium permanganate (Figure 4).

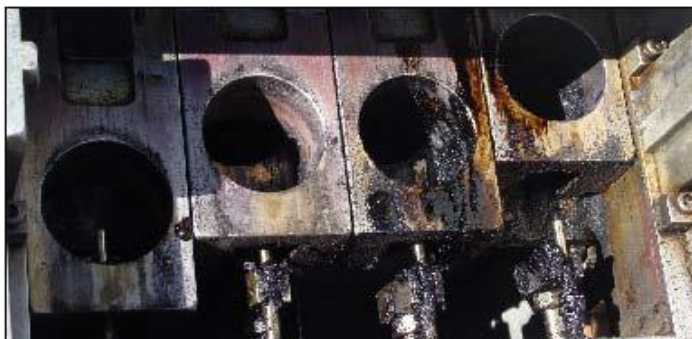
Figure 5.

Additionally, there have been several documented instances where excessive permanganate residue inside the chutes caused the machine to jam which significantly increases the chance of a fire ([SAFECOM 10-0077](#) and [SAFECOM 10-0081](#)). The spheres were cracking at the seam joint allowing the permanganate to release into the PSD machine. The loose permanganate from the cracked and broken spheres caused the PSD machine to become clogged with material and jam well prior the normal cleaning cycle (Figure 5). The manufacturer (PremoFire/Vanguard Plastics) has since identified and corrected the problem. The suspect spheres were manufactured between June and November 2009, but may not be limited to those exact dates.

Gummed up PSD machine after approximately 3,000 spheres were dispensed
