Appendix A

Helmet Creek Restoration & Monitoring Work Plan

Adak Petroleum Diesel Spill

April 13, 2013 Final

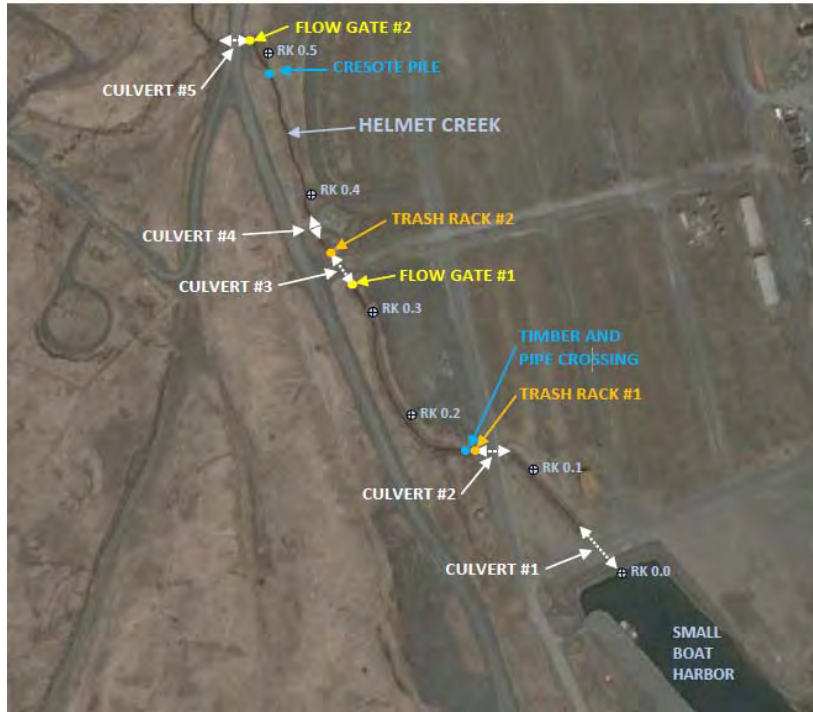
Figure 1: Lower Helmet Creek showing structures

Diesel fuel spilled into Helmet Creek on Adak Island, Alaska on January 11, 2010 injuring natural resources in the creek and the nearby estuary, intertidal and nearshore marine habitats. Investigations performed by the Responsible Party (RP) and the federal and state natural resource trustees (Trustees) during October 2010 and September 2011 identified restoration opportunities on Helmet Creek. The pictures below identify the stretch of Helmet Creek proposed for restoration (see, Figure 1 and Figure 2).

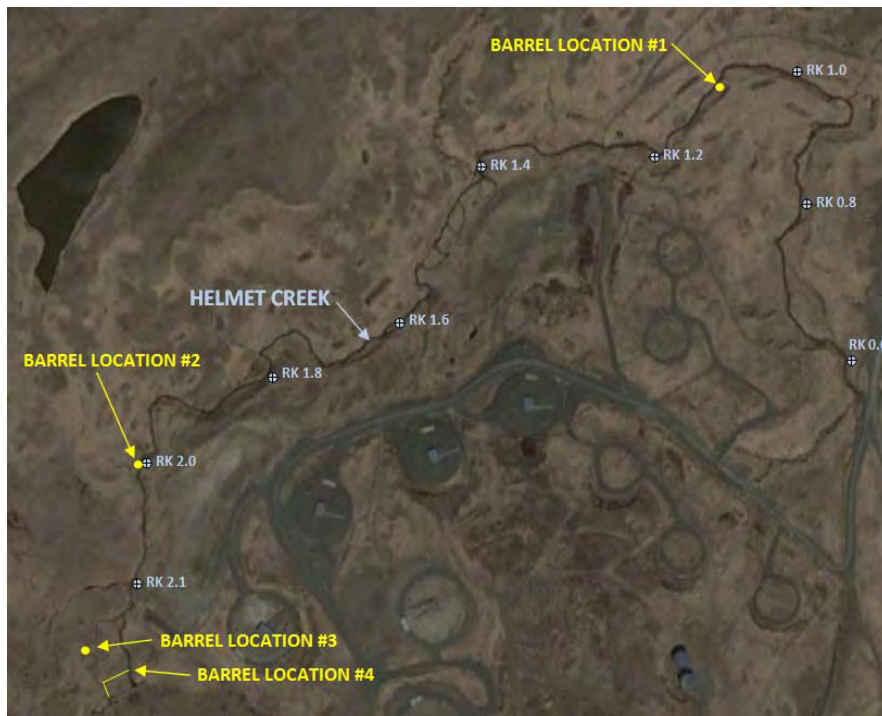
Figure 2: Upper Helmet Creek showing structures

- 1) Barrel Location #1;
- 2) Barrel Location #2; and
- 3) Barrel Locations #3 and #4 (see Figure 2).

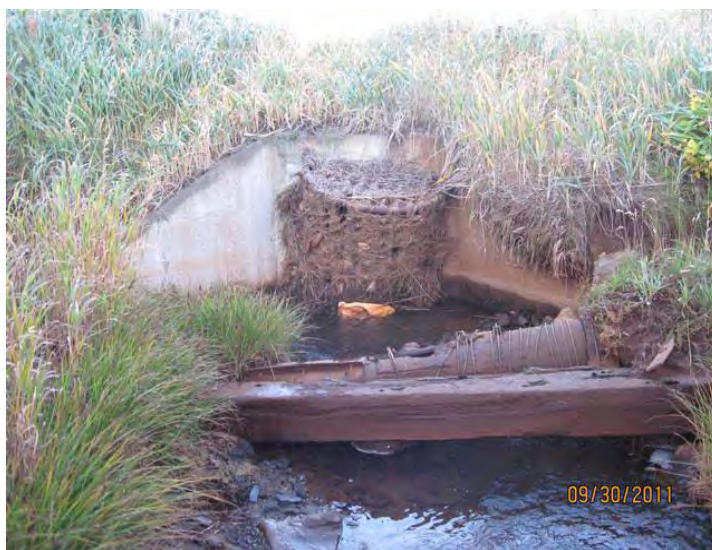
Figure 3: Wood stave pipe and timber

Roughly 15 to 20 pieces of anthropogenic debris (plywood, scrap metal, etc.) were noted in the creek during the various surveys. There is some risk that this material could adversely influence habitat quality or potentially shift and cause future fish passage blockages. Virtually all of the material can be easily removed by hand in a day. A team of two or more people shall walk the channel from the small boat harbor to the spill origin site -- collecting and hauling away all anthropogenic material located within or immediately adjacent to the creek. On future monitoring trips, this exercise will be repeated to remove any future accumulations. A wood stave pipe and timber are located immediately above Culvert #2 (Figure 3). This wood stave pipe and timber may require mechanical effort to cut away the objects close to both banks.

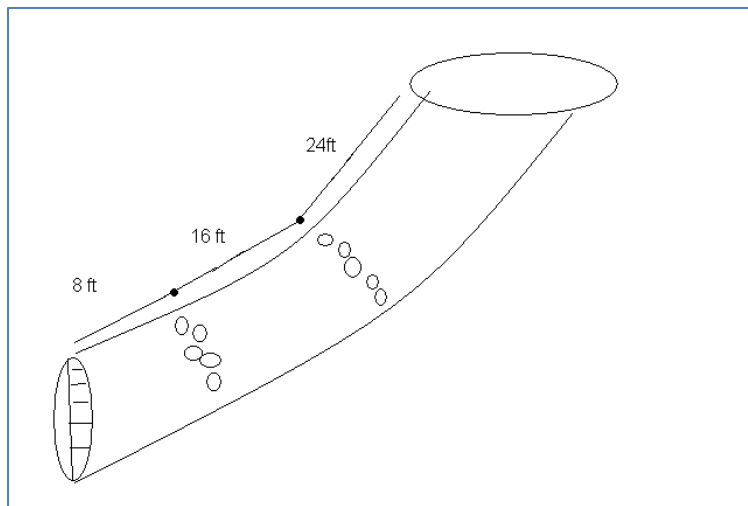
Figure 5: Drawing of potential step pool configuration option

- Fill in the drop area of the stream and possibly remove some of the stream bed at the top of the drop (see Figure 4).
- If the channel grade exceeds four percent, create two, or possibly three, equally spaced steps (see Figure 5). The steps should reduce the effective grade for fish passage, help trap sediments, and should not disrupt stream conveyance. All steps will include gaps as necessary to minimize fish jump height.

Currently, a step is present before the downstream edge of Culvert #4. The diameter of these rocks ranges from 7 to 18 inches. It is likely that this would also be a suitable diameter for any future steps. Configuration of the rocks in the step will be determined once the trash racks are removed and flows are observed.

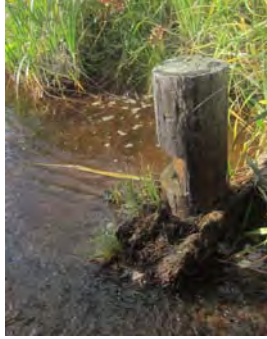
Figure 6: In-stream Piling

A total of three pilings are present between Culverts #4 and #5. One is in Helmet Creek (see Figure 6) and two others are approximately two feet from the bank.

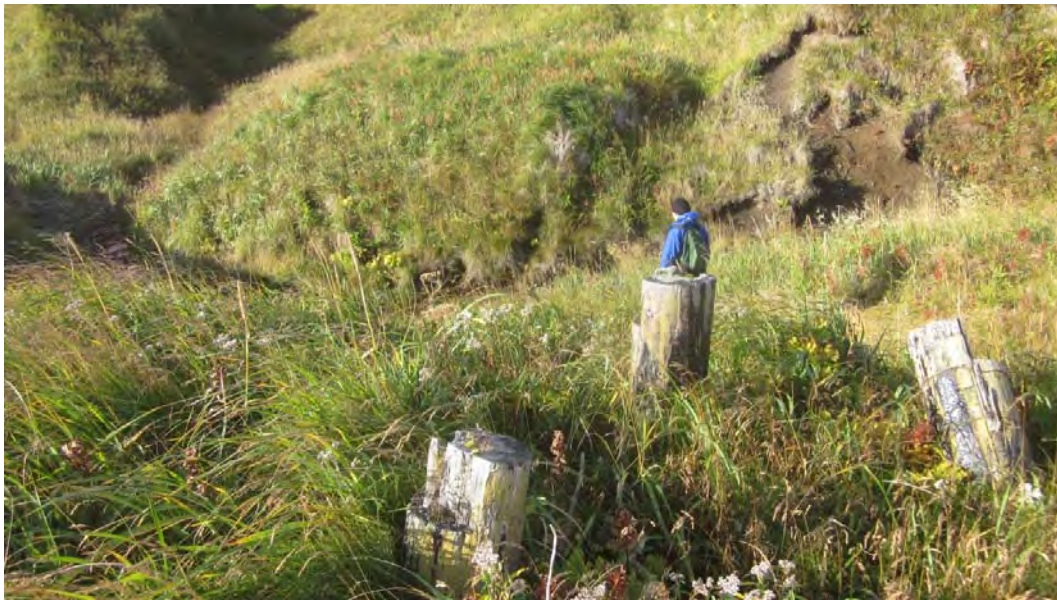
Figure 7: Upper Bank Pilings

Three additional pilings exist on the upper bank near the road. Again, due to close proximity of the road, removal can be conducted with machinery that is road-based. The pilings are above the high-water mark of Helmet Creek, but drainage into the creek would be affected by the creosote coating on the pilings. Piles that cannot be readily removed from the road will be cut off at ground level and the surface capped with clean soil and native seed or vegetation mat, if available (See Figure 7).
