Interagency Aviation Lessons Learned

No. IALL 10-02

Subject: A near-miss with a wire fence and several Lessons Learned

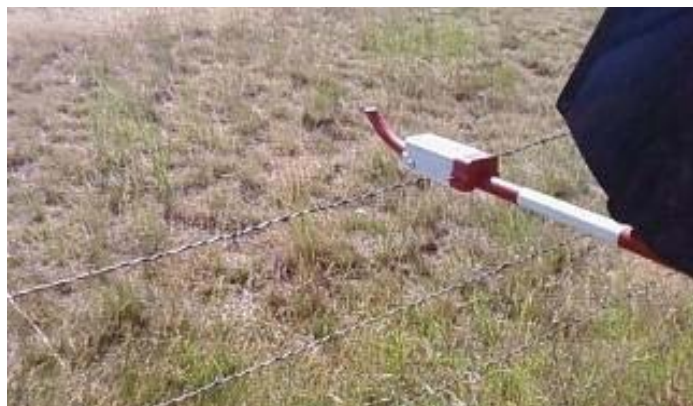
The next morning the helitack supervisor and pilot were alarmed to see just how close the tail rotor had come to hitting the fence the night before (figure 1). Fortunately, the helicopter was not damaged. As a result, several valuable lessons were learned by this crew, and because of their excellent SAFECOM, these lessons can now be shared with the rest of the Interagency aviation community.

Figure 1. Proximity of tail stinger to fence.

1. Hazard Identification and Communications: During the landing the helitack supervisor saw the fence, recognized it as a hazard, and warned the pilot (*Hazard Identification and Crew Resource Management*). The pilot's acknowledgment "Yes, I see it" suggests that he saw the fence, understood the hazard and would maneuver the helicopter to avoid the fence. Always practice being explicit in aviation communications, never leave room for doubt

2. Distraction: As the truck approached the helicopter from the left the pilot diverted his attention from the fixed hazard (the fence) to the more imminent hazard (the truck). The distraction of the new threat was enough to divert the pilot's (and the rest of the crew's) attention away from the fence (*Distraction and Loss of Situational Awareness*). While an active threat (the pickup truck) may take priority over a latent threat (the fence) a conservative approach would be to suspend the landing or to go-around until the situation is understood and under control. Pilots should consider using other team members to monitor lower risk hazards when they have to focus on more imminent threats.

3. Team Work: The helitack supervisor did a good job identifying the hazard posed by the fence and communicating it to the pilot (*good team work*). The distraction posed by the approaching truck apparently diverted the attention of the entire crew so that no one monitored, or no one spoke up about the fence (*breakdown in team work*). The pilot could have used his crew to his advantage by directing one or more of them to keep him clear of the fence while he kept an eye on the truck and landed.

4. Low Visibility / Low Light Operations: The aircraft landed "legally" before the end of civil twilight but, due to the cloud cover and the shadows from the nearby mountain range, the crew's ability to see unlit hazards such as the fence was degraded. Knowing that this airfield is always going to be in the mountain's shadow before the end of civil twilight should be discussed during the mission planning phase to allow aircraft to return early.

5. Post Flight Inspection. It appears that at the end of a long and successful day the crew simply shutdown the aircraft, transferred their gear to the truck, and called it a day. How the crew tied down the aircraft without noticing the tail rotor's proximity to the fence is not known. A walk around inspection of the aircraft is a "best practice" that would have identified the hazard posed by the fence. Thorough post-flight inspections often catch discrepancies that can be fixed before they result in a mission delay or cause the aircraft to be unavailable. Similar to a good pre-flight inspection, crews are encouraged to always conduct a careful post-flight inspection.
